**UNITED STATES DISTRICT COURT  
NORTHERN DISTRICT OF CALIFORNIA**

CHART INC.

Case No. 3:20-cv-05011

**COMPLAINT AND  
DEMAND FOR JURY TRIAL**

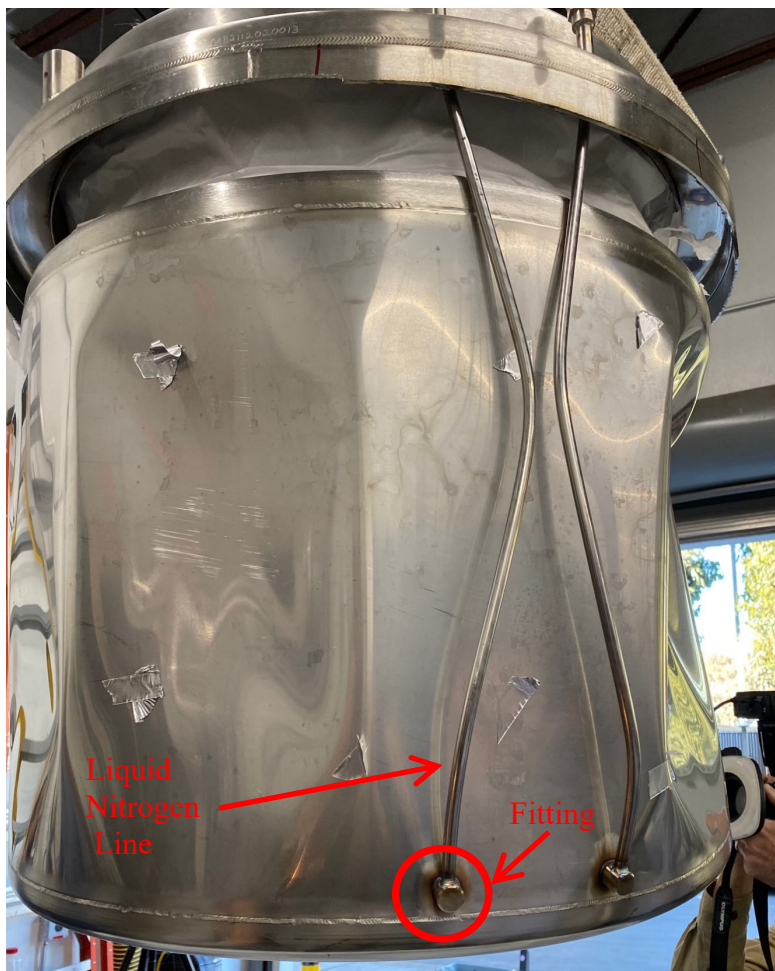
24. Tank 4 was manufactured with a metal tube that is used to refill the tank with liquid nitrogen. The tube ran from the top of the tank, down through the vacuum space between the inner and outer vessel, and then into the inner vessel near the bottom of the tank.

25. The picture below was taken after the outer vessel of Tank 4 was removed. The liquid nitrogen tube is on the left and the red circle shows where it connects to the inner vessel through a fitting.

*Liquid nitrogen tube feeds into Tank 4's inner vessel*

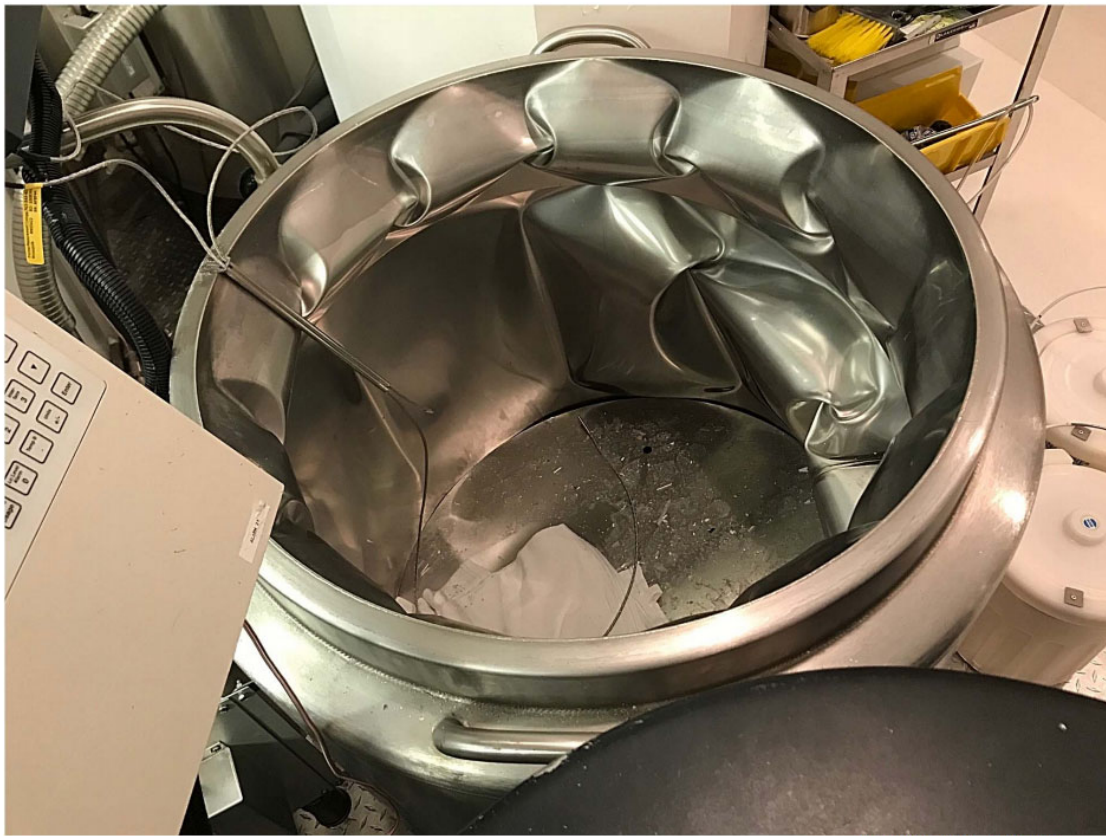
March 6, 2018, 9:03 AM

33. The crack and accompanying leak of liquid nitrogen into the interstitial space both destroyed the vacuum insulation that allowed the inner vessel to stay cold and exerted significant pressure on the space between the tank's inner and outer vessel. The inner vessel gave way and crumpled. The following image was taken approximately 36 hours after the PFC embryologists discovered the Tank 4 failure and moved the affected eggs and embryos to another tank.

*Tank 4 after the incident*

34. This dramatically imploded tank is yet another indication of a cracked failure. As part of its compliance with the European Union’s Medical Device Directive, Chart was required to attempt to identify every way that its cryogenic freezers could theoretically fail. Representatives from Chart’s various departments came up with over a hundred potential failure modes. One of them was a cracked weld at the liquid nitrogen fill tube—exactly what expert analysis revealed happened to PFC’s Tank 4. If that weld did crack, Chart wrote that the result would be: “Liquid draws into vacuum space, expanding rapidly and causing an inner vessel implosion, total vacuum loss. Loss of function of the freezer.”
